# Naval Submarine Medical Research Laboratory

NSMRL/TR--2007-1252

March 28, 2007

## **Results of Inspections of MK-10 Submarine Escape and Immersion Equipment Life Rafts Following Leeway Testing**

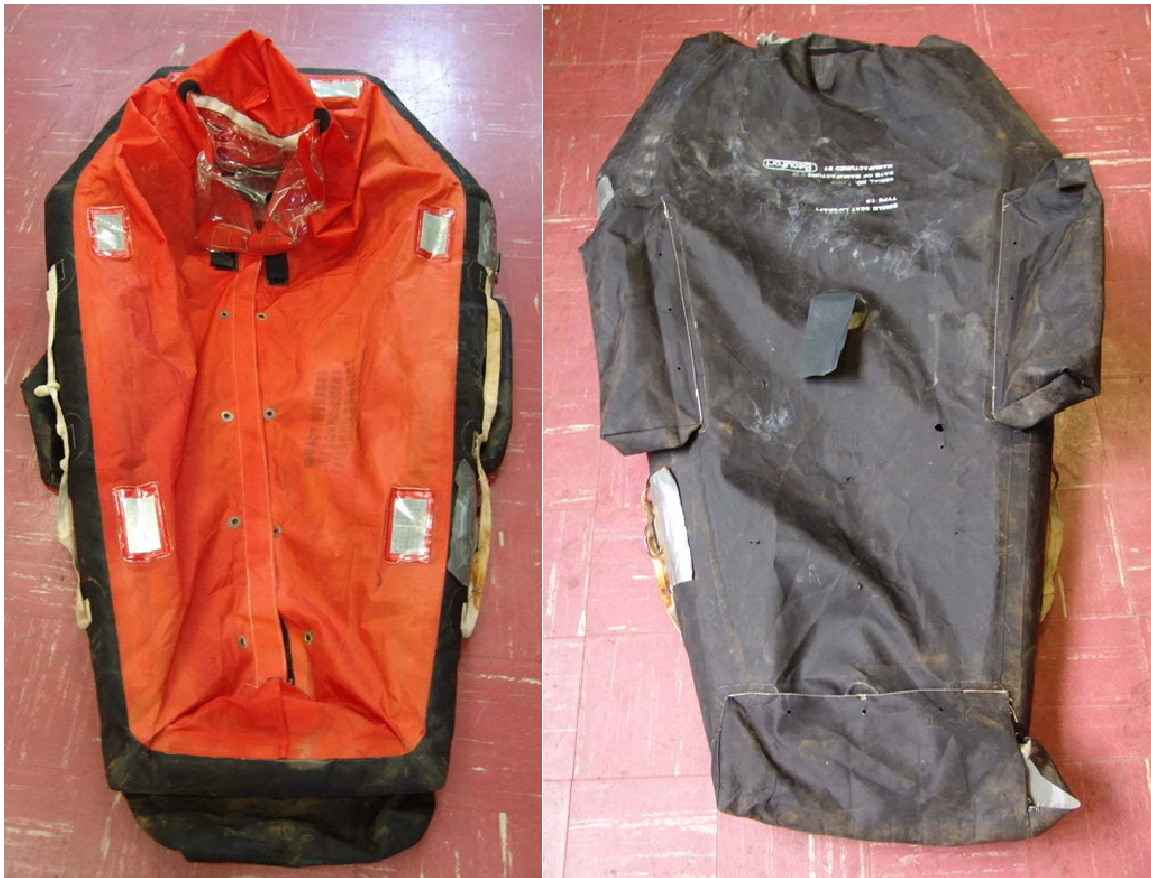
Figure 14: Raft Serial Number 0364837 Top View (Left) and Bottom View (Right)

- Two D-rings were added to left side. Eight grommets added to canopy.
- Forward stability pocket was torn along right side seam (As viewed from top).

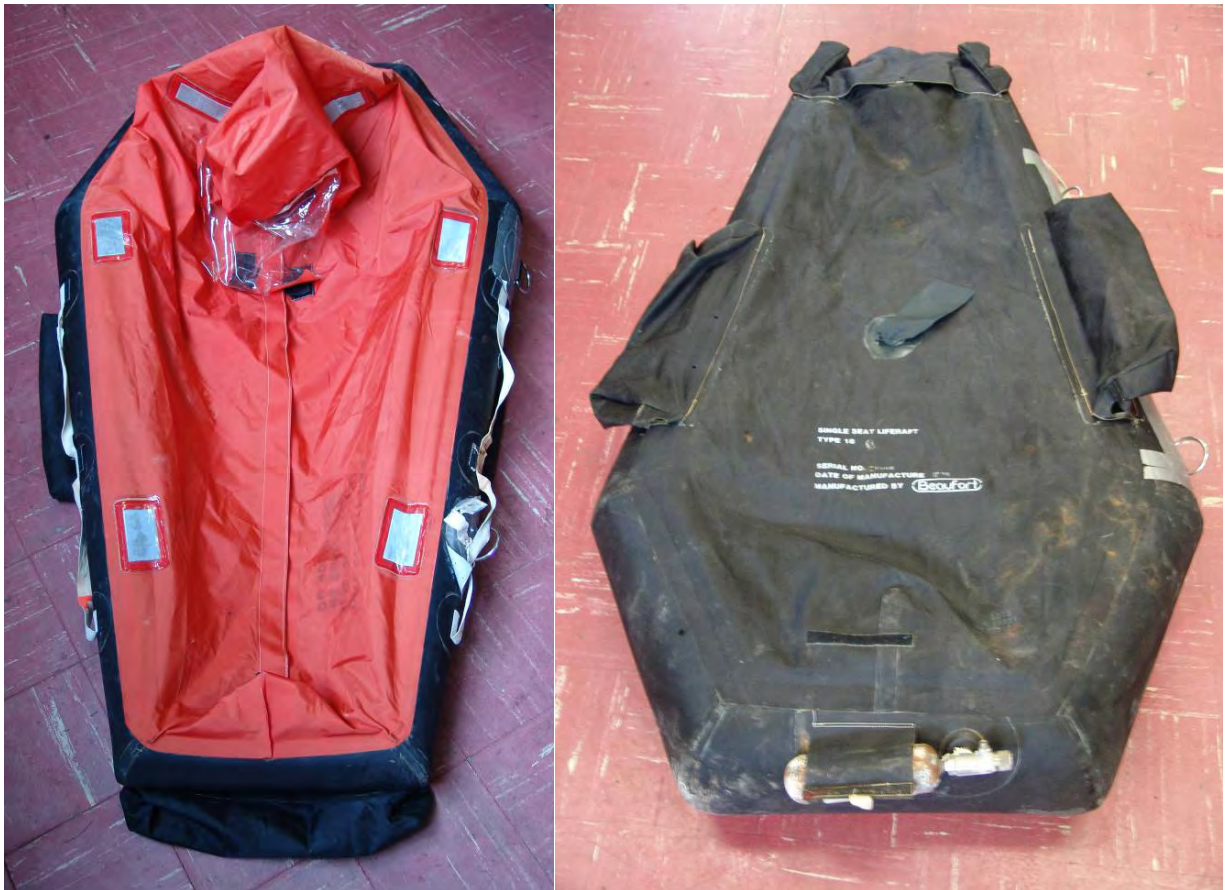
Figure 22: Raft Serial Number 0364812 Top View (Left) and Bottom View (Right)

- Two D-rings were added to the left side of the raft. No grommets added to canopy.
- No patches found.
- No leaks in the seams or fabric of the flotation chamber were detected.
- The Over-Inflation Protection relief valve did function (open) as raft reached full inflation and then did not fully reset. Attempts to reseat the valve by directing a stream of water onto the valve were not successful and the valve continued to leak.

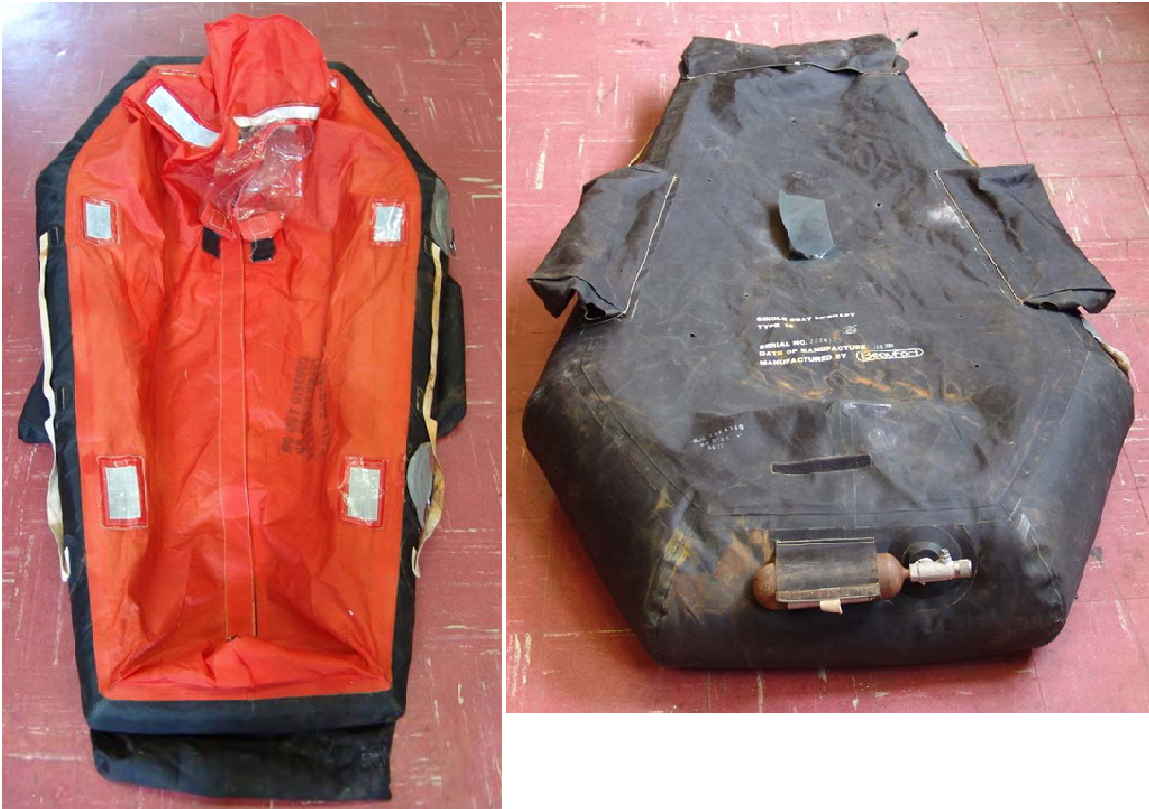
Figure 26: Raft Serial Number 2204171 Top View (Left) and Bottom View (Right)

- Two D-rings were added on left side. No grommets added to canopy.
- Forward Stability pocket left side seam (As seen from top.) was ripped open for entire length.
